**ABU GHRAIB DAIRY
ABU GHRAIB, IRAQ**

**SIGIR PA-09-172
JANUARY 14, 2010**

Summary of Report: PA-09-172

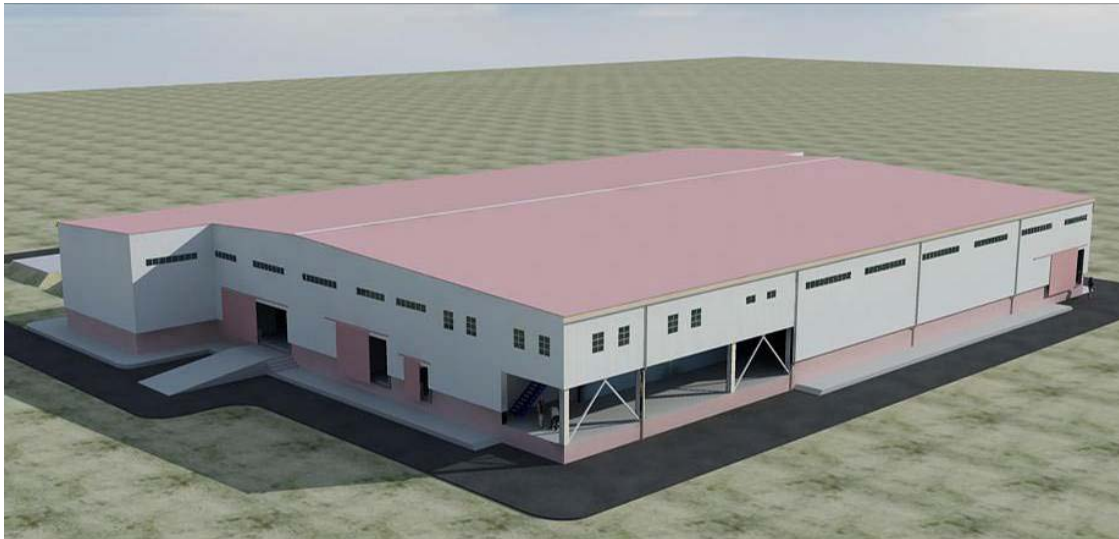
Figure 1. Rendering of dairy building and surrounding area (Courtesy of TFBSO)

The contractor designed the construction of an approximately 2,900 square meter facility (Figure 1), including water and fuel storage tanks. The contractor provided detailed architectural plans for the project, including exterior renderings of the facility, exterior elevations, several interior cross sections, and floor plan information regarding building layout and room dimensions.

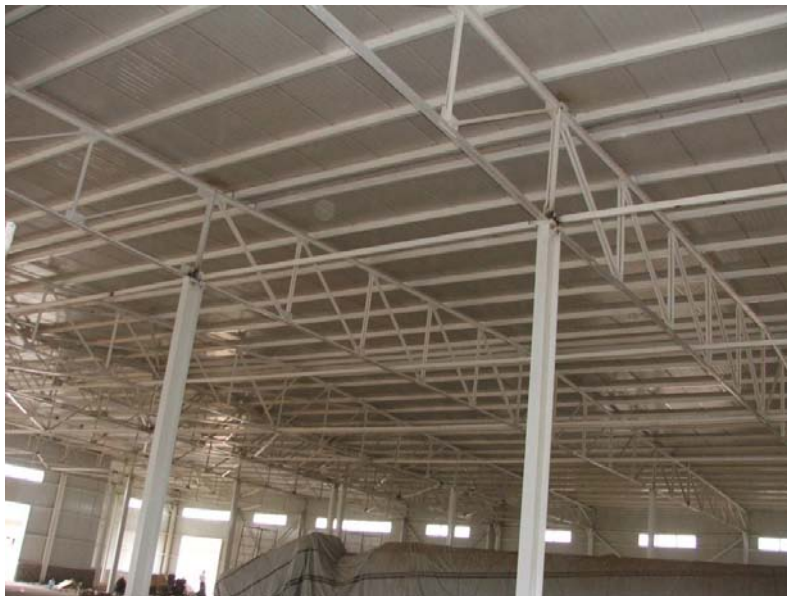
Site Photo 6. Lateral brace connection at column cap plate

At the time of the site visit, all structural steel, with the exception of the mezzanine, had been erected. The steel structure for the dairy building consisted of continuous steel trusses supported by steel columns (Site Photo 6). The trusses at the ends of the structure and at either side of the expansion joints were braced with diagonal bracing in the plane of the upper and lower chord. The trusses are also braced transversely in the plane of the lower chord with steel braces running the length of the structure.

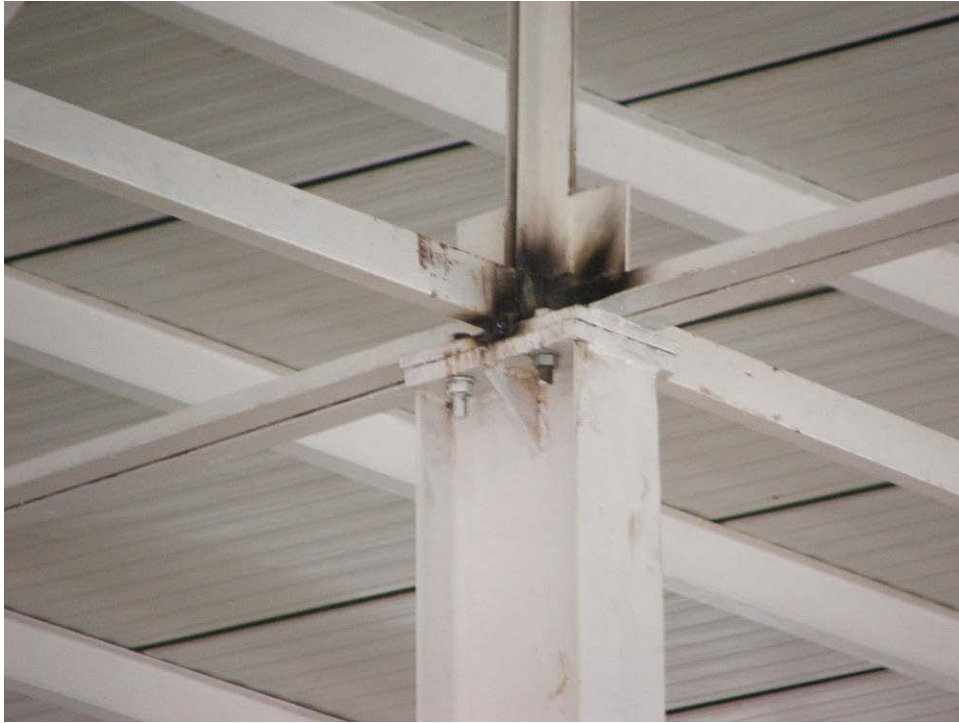
Site Photo 9. Lateral brace connection at column cap plate

Lower bracing was welded to the column cap plate (Site Photo 9), which acts to resist lateral sway at the top of the column. Since the truss is continuous, loads from the roof will induce compressive stress in the bottom chord above the column. The compressive stress could produce buckling in the lower chord. The connection between the truss and the column is effectively a hinge point, and the lateral bracing is essential to resist this buckling and prevent movement of the column.

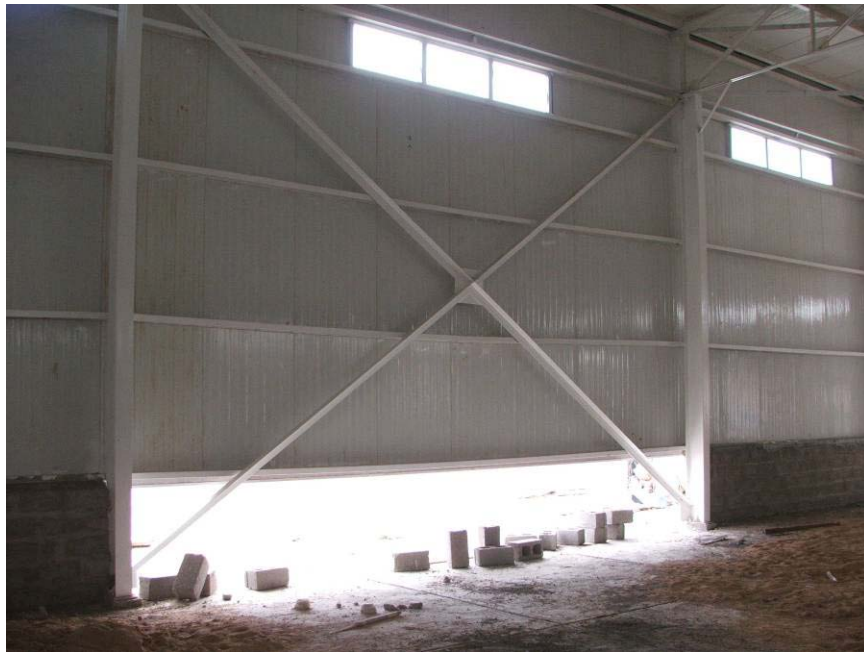
Site Photo 10. Lateral cross bracing between columns

Lateral bracing is provided along exterior column lines of the structure. The bracing is provided as vertical steel cross-bracing along the exterior column line perpendicular to the steel trusses (Site Photo 10). As previously noted, the bracing interferes with the

CMU walls due to a contractor construction error. The bracing appeared to be completely installed at the time of the visit.

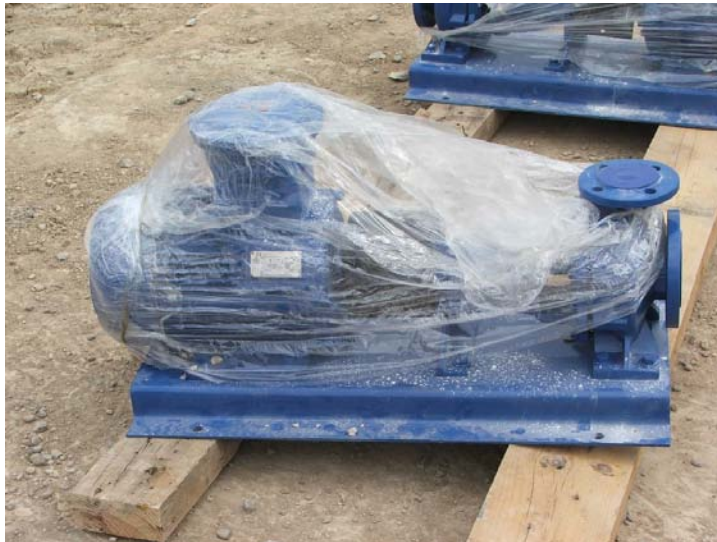
Site Photo 14. Pumps for fuel oil transfer

Pumps were on site awaiting installation (Site Photo 14). According to the contractor, they are fuel oil transfer pumps, which will be placed in the pump vault²² between the two fuel oil tanks.
